WATER UTILITY MASTER PLAN

Sierra Lakes County Water District

January 2024

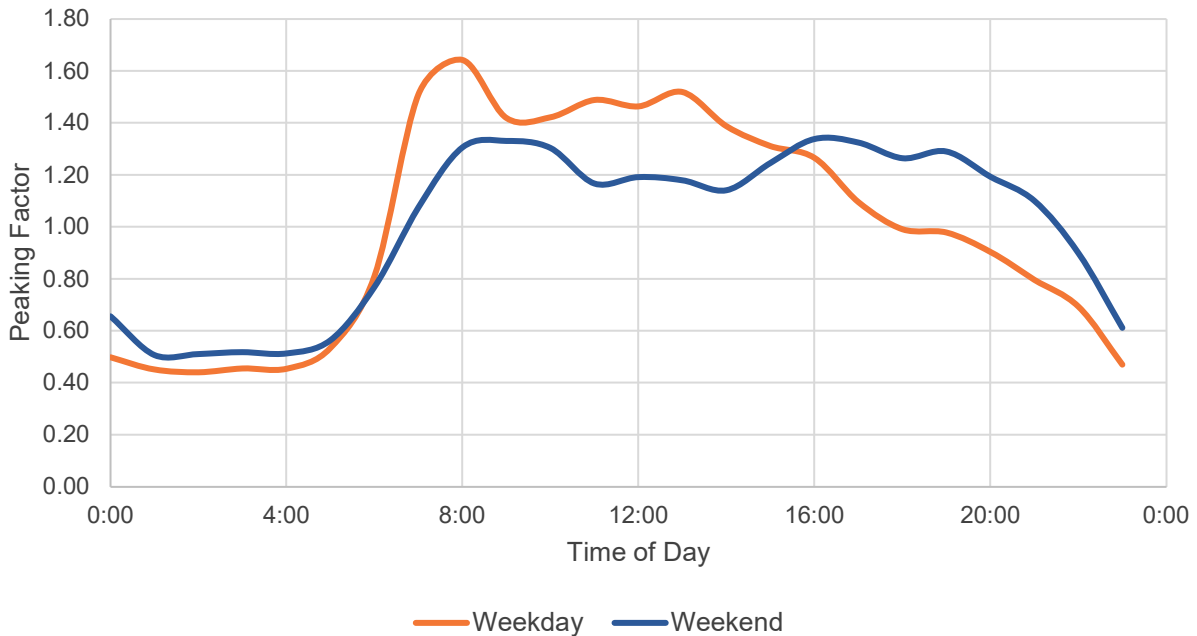
Figure 4: Weekday and Weekend Diurnal Curves

Additional analysis was performed to determine the effects of the transient population on water demand. Calculated water demands were categorized by the day of the week, and water usage during the weekend was compared to water usage the rest of the week. The weekend to weekday peaking factors for all months analyzed can be found in Table 6. Diurnal curves for average weekday usage and average weekend usage were also calculated and are shown in Figure 4.

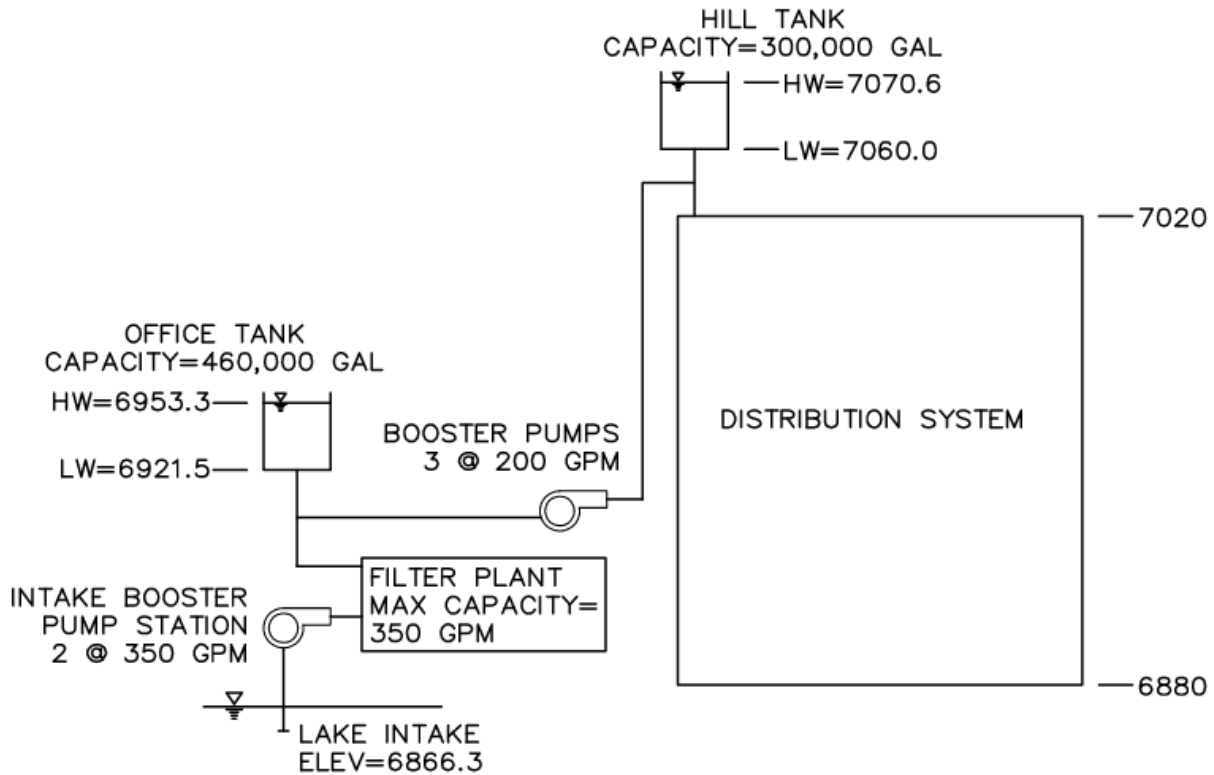
Figure 7: Existing Water System Schematic

Due to the smaller size of the utility service area, the SLCWD water system is comprised of a single pressure zone. Figure 7 is a schematic of the system hydraulic grades, and Figure 8 is an overview map of key system infrastructure and the layout of the SLCWD system.

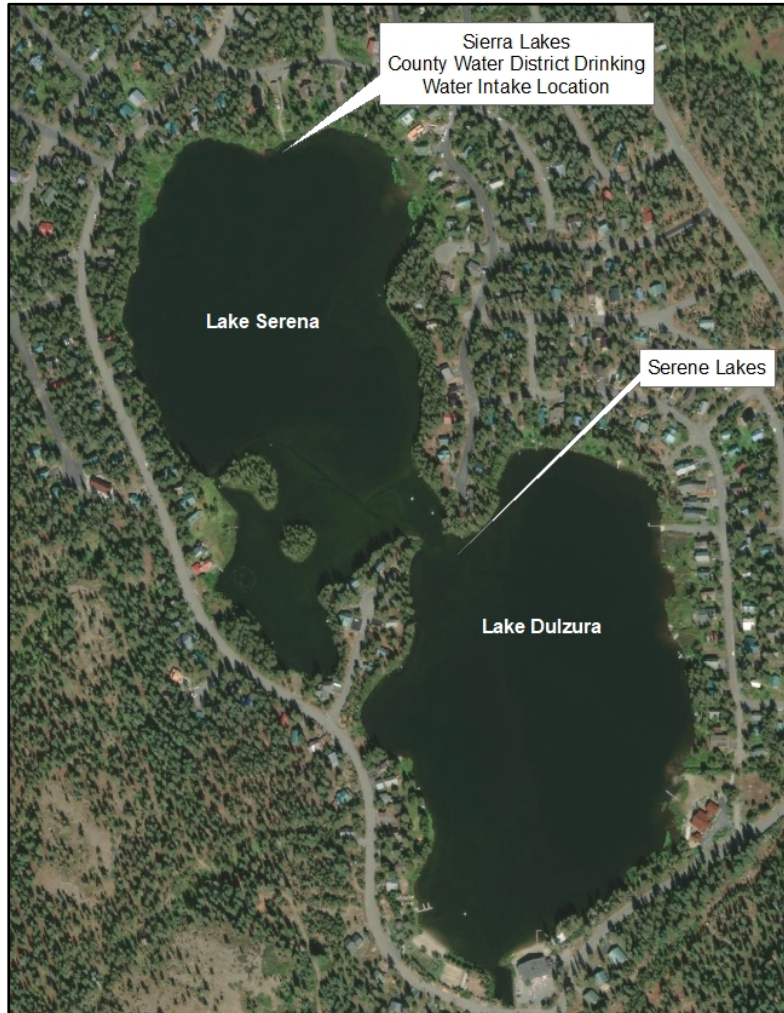
Figure 1: Serene Lakes Overview Location

The District maintains and operates two sources that provide the community's drinking water. The primary source is Lake Serena, the northernmost lake, with pumping and treatment capacity of up to 200 gallons per minute (gpm). The secondary source is a well which is permitted as a backup supply. The current intake pipe is located on the northern end of Lake Serena, adjacent to the District's pump house where the water is pumped to the District's treatment plant.
